NWC TP 6517

An Evaluation of Permanent Solder Masks for High Reliability Applications

Donna J. Sanger
Engineering Department

FEBRUARY 1984

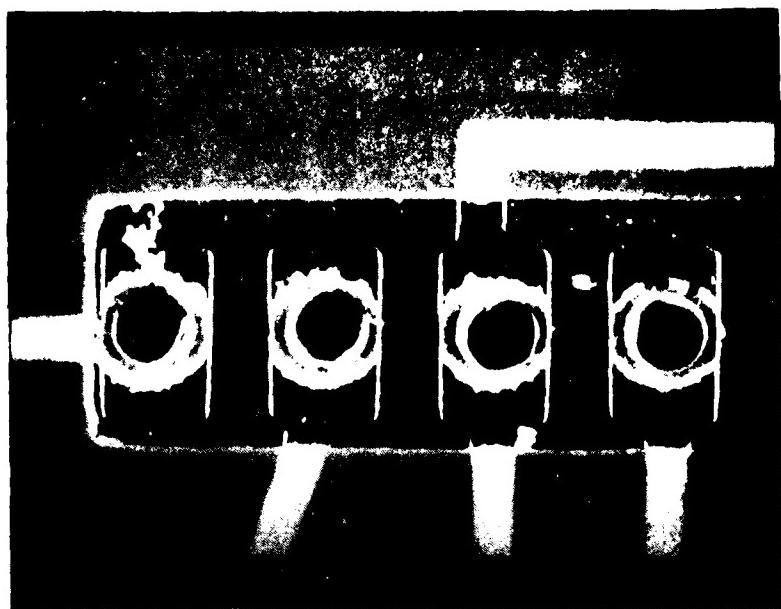
A visual inspection of Vacrel 740FR and Vacrel 740S dry film solder masks showed mask on the pads and in the plated-thru-holes. This was explained as a misalignment of the front-to-back registration in the solder mask artwork. Light scattering during the ultraviolet exposure period allowed the misaligned areas near the pad openings to be partially exposed. During the development process, the solvent was unable to remove the partially exposed mask, leaving rough and irregular edges on the holes. The rough edges easily chip and flake, settling onto other areas of the board, including the plated-thru-holes. See Figures 2 and 3.

FIGURE 2. Vactel 740FR. Solder Mask on Perimeter of Plated-Thru-Holes.

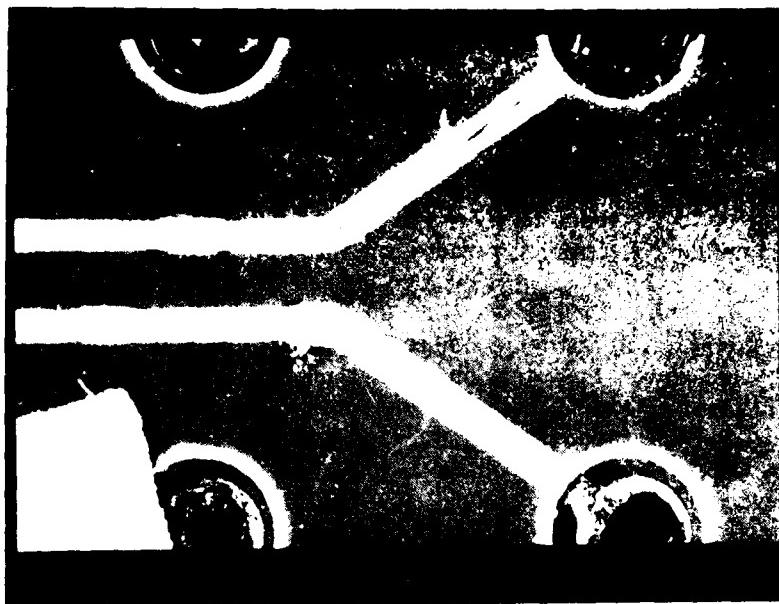
The cleanliness test solution caused the Laminar RM to separate from the laminate and the metal in many areas but flux remained trapped under the mask that had not separated. See Figures 18, 19, and 20. Probing easily flaked the mask off of the board. See Figure 21. Ionic contamination values were unacceptably high at an average of 15 micrograms/square inch.

FIGURE 18. Laminar RM Mask Loose and Cracked on "Y" Pattern.

FIGURE 19. Laminar RM Mask Lifted and Blistered on Comb Pattern.

FIGURE 20. Laminar RM Flux Trapped Under Mask on Ground Plane.

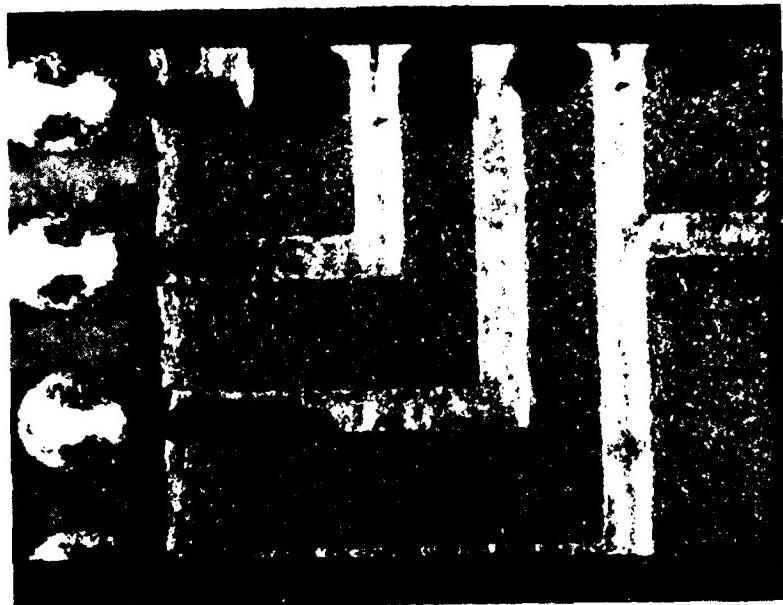
FIGURE 38. Hysol SR1010, Flux Trapped Under Wrinkled Mask on Ground Plane.

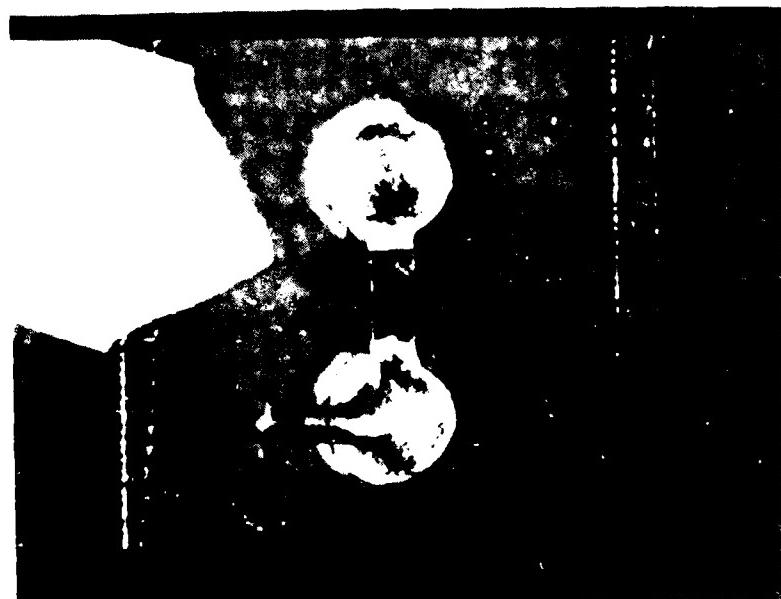
FIGURE 44. Lonco 222-M, Mask Bleed Residue Caused Non-Wetted Copper.

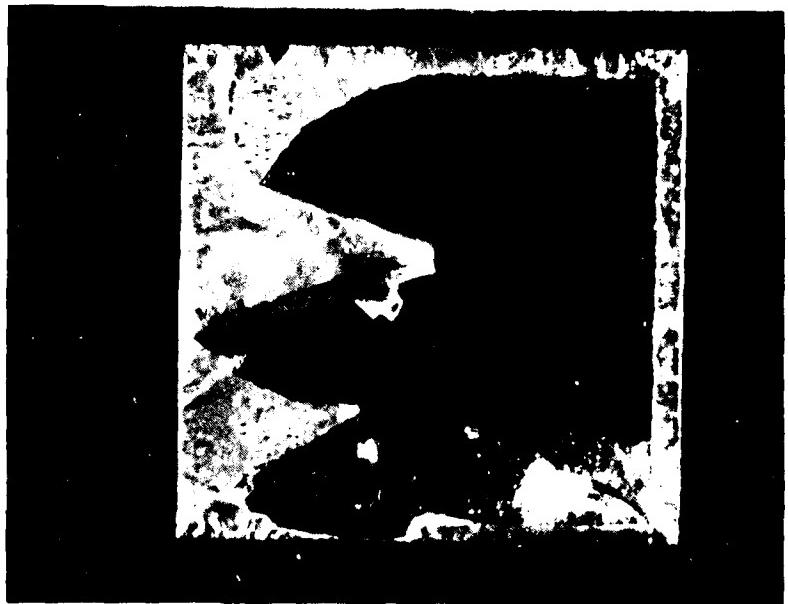
Wave soldering of the Lonco 222-M solder mask caused the mask to separate from the tin/lead ground plane and allowed flux to be trapped under the mask that remained. See Figures 47 and 48. The flux under the mask seeped out later, leaving flux residue near the pad openings.

FIGURE 47. Lonco 222-M. Mask Lifted From Ground Plane and Trapped Flux.

FIGURE 48. Lonco 222-M. Mask Lifted From Ground Plane and Trapped Flux.

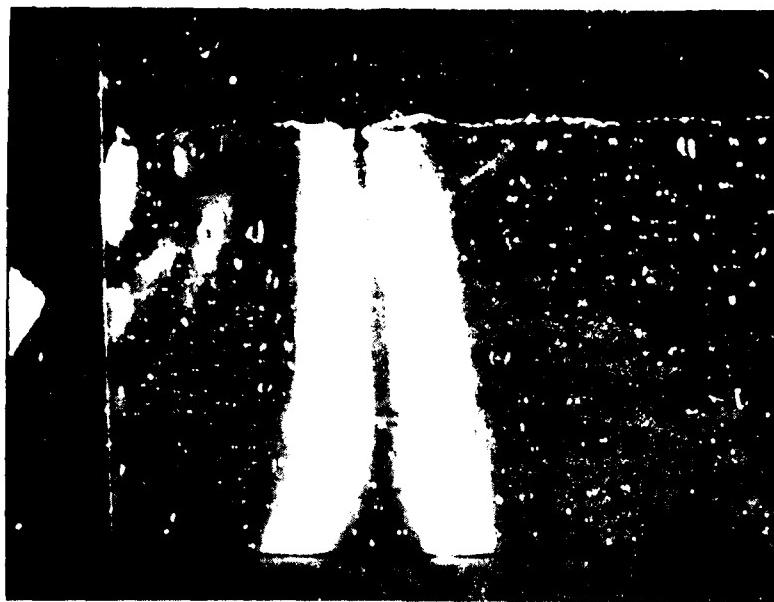
FIGURE 58. MacDermid 9446, Flux Trapped Under Solder Mask on Ground Plane.

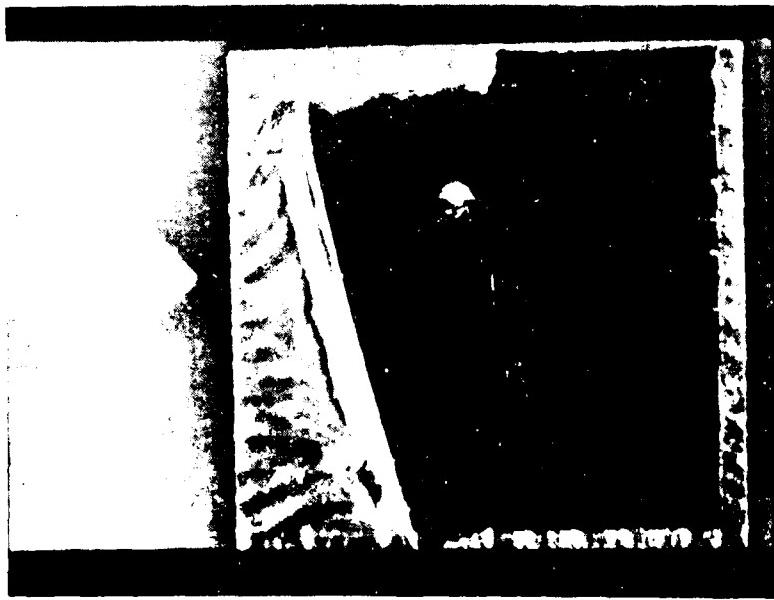
FIGURE 59. MacDermid 9446, Mask on Ground Plane Rolled Back by Soldering Process.
